**Final Report**  
**STUDY METHODS TO STANDARDIZE**  
**THERMOGRAPHY NDE**

Contract Number: NAS8-38609  
Delivery order: 174

February, 1998

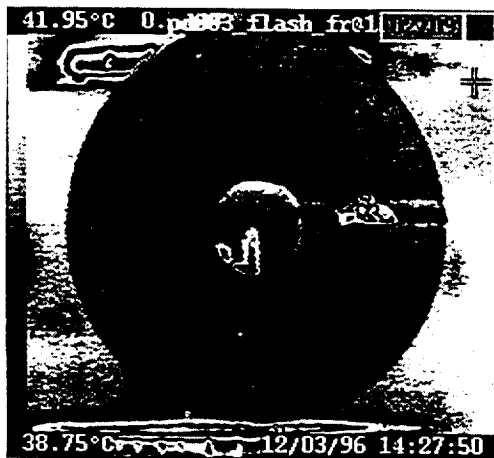
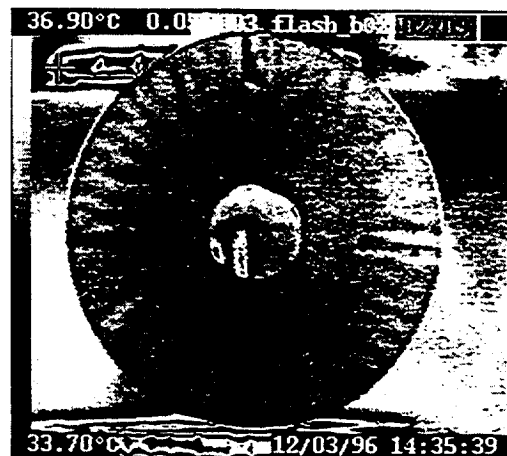
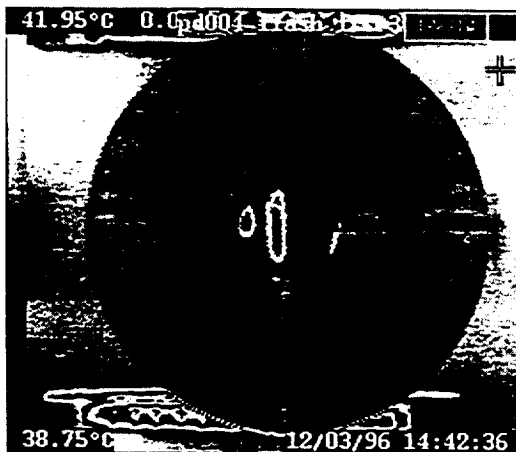
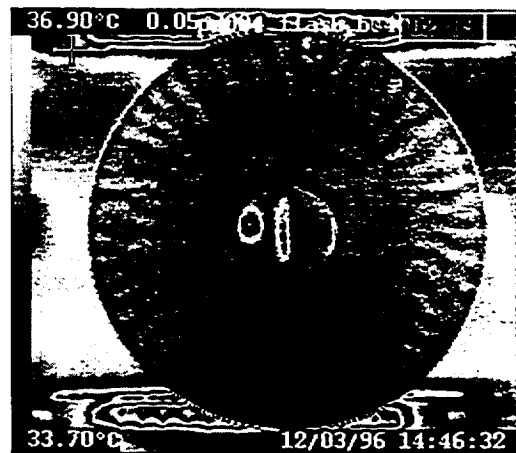
No thermal abnormalities were detected.

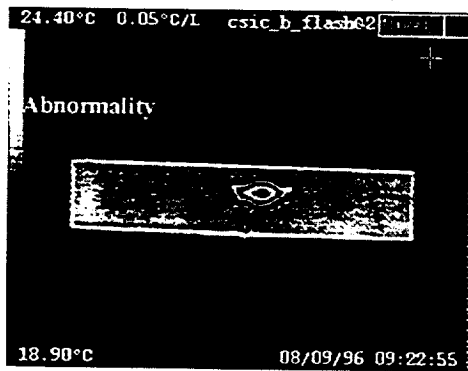
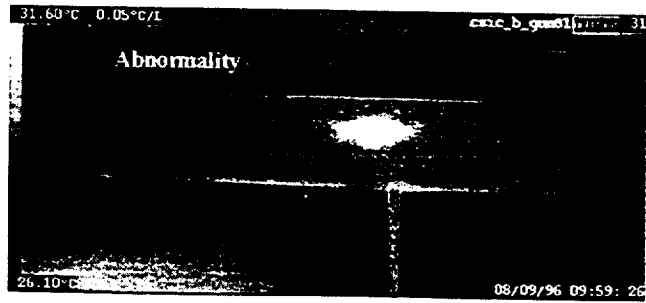
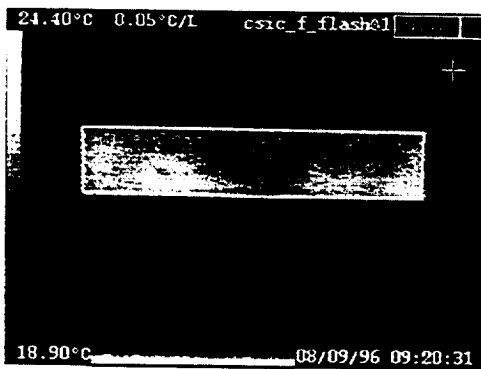
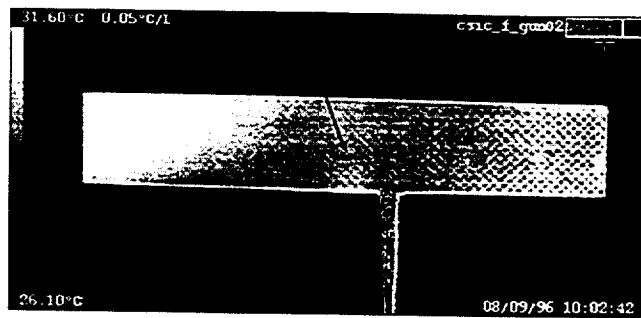
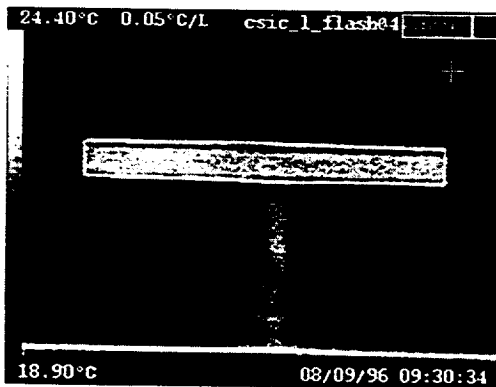
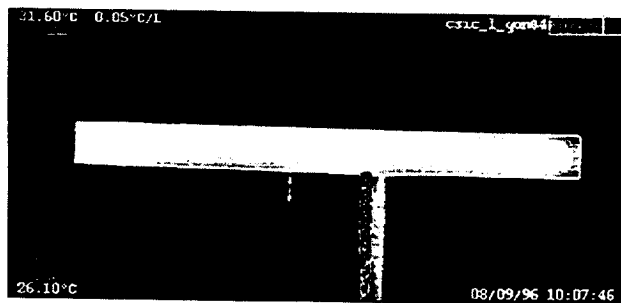
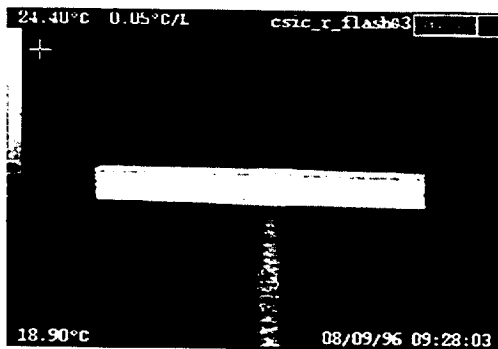
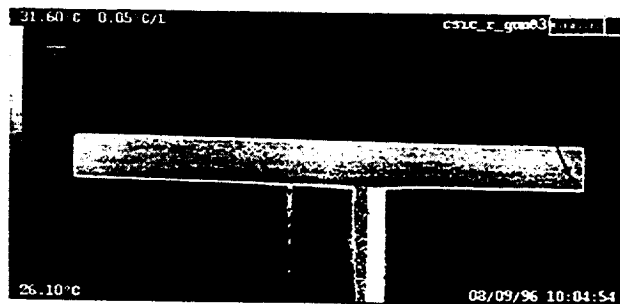
To determine the depth to which the thermographic inspections were penetrating the blisks, a 5.5 by 0.5 by 0.25 inch carbon/silicon-carbide bar was supplied for use as a thermographic defect standard. The bar was inspected using both flash and slow heating before any planned defects were added to determine the initial quality of the bar. As shown in the following figures a large abnormality was found on one face of the bar. It appears that this region is resin starved and may therefore have high porosity.

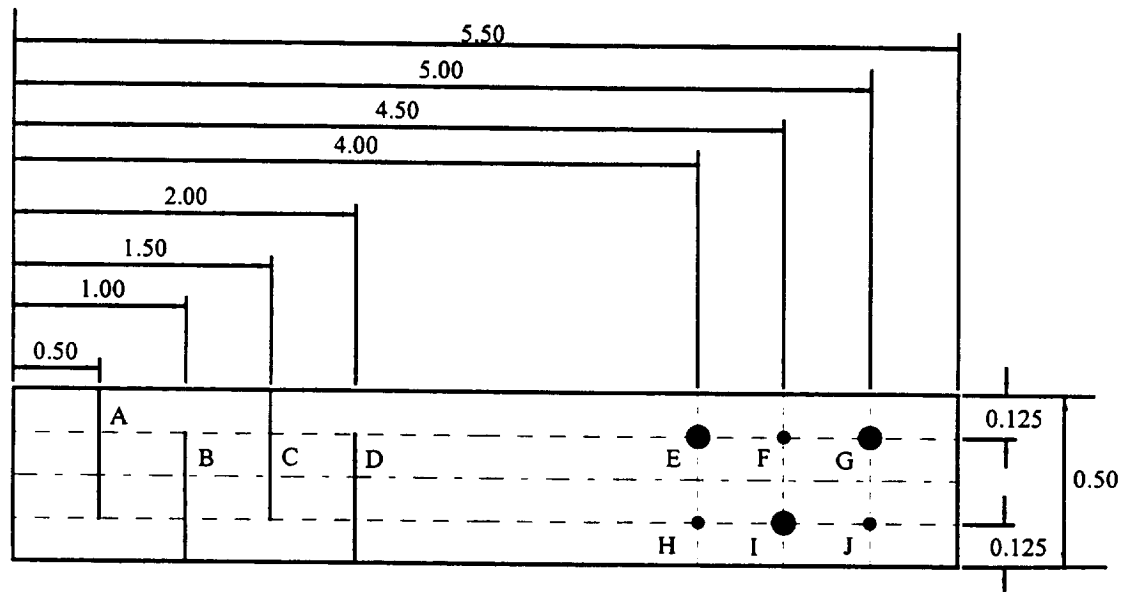
All units in inches

Defects were manufactured by drilling flat bottom holes through to specified depths as shown in the following figure. None of these planned defects were detected using either flash or slow heating. More work will need to be done with the carbon/silicon-carbide material to determine the sensitivity of thermography to detecting defects in that material.

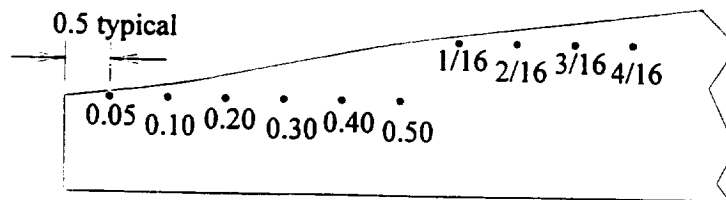
To determine how deep the thermographic inspection was penetrating into the nozzle a series of holes were drilled into the side of Nozzle Segment SN 47. Ten holes, 1/16 inch diameter, were drilled parallel with surface, approximately 1 1/4 inch deep. The holes were drilled 1/2 inch apart at depths of "0.1, 0.2, 0.3, 0.4, 0.5", "1/16, 1/8, 3/16 and 1/4" of an inch from surface.

The only holes which were visible were 1/16 and 0.05 inch below the surface. Since the primary defects of interest were over 1/4 inch deep thermography was ruled out as a viable technique for the inspection of the nozzle segments.

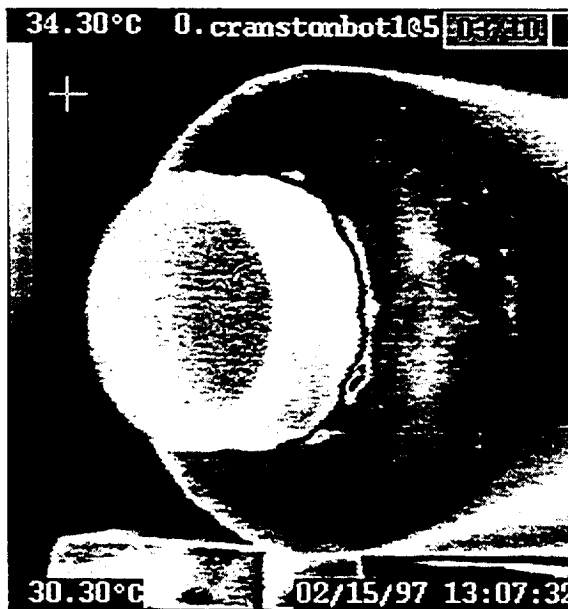
Bottom 1

The end and quarter end views of the vessel shows the same sort of thermal abnormalities as the side views. Small hot regions of potential disbonded shell can be seen to extend all the way around the end of the vessel.

It should be noted that these some of the thermal abnormalities shown may be due to sources other than disbonds, such as resin rich/starved regions, nonuniformity of the inner liner or porosity in the shell itself. To confirm the source of the thermal abnormality a vessel would need to be thermally inspected then dissected.

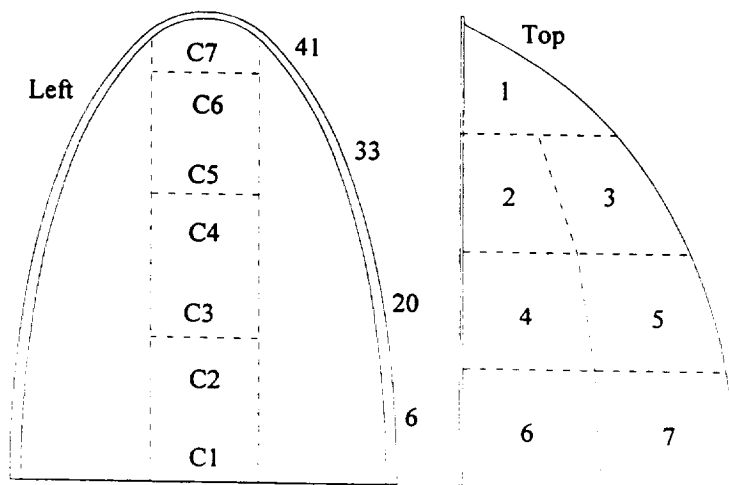
The thermographic inspection yielded 13 potential regions of porosity, including the six previously located by ultrasonics. The following figure outlines the six regions found by UT and the 13 found by thermography. These thirteen regions are also shown on the resulting thermograms.

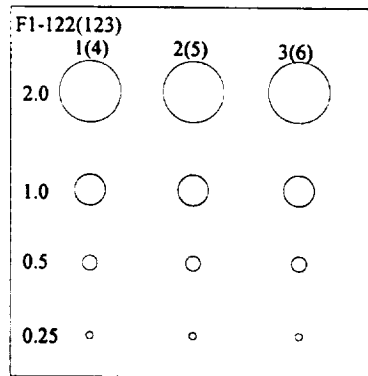
Panel F122/123 Panel F122/123 was created at JSC to investigate methods to simulate disbands between the faceplates and core. The panel featured 15 ply, graphite/cyanide-ester faceplates on a nomex honeycomb core. The defects are identified in the following figure.

| 2. Missing cobond adhesive | 5. Teflon insert |
| 3. Release agent | 6. Missing adhesive filled with cured adhesive |

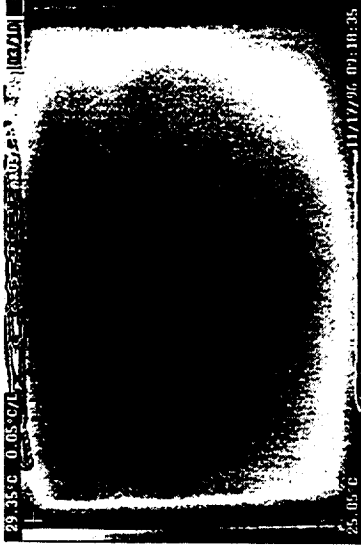
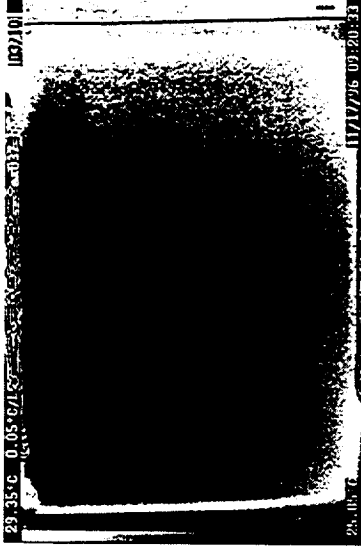
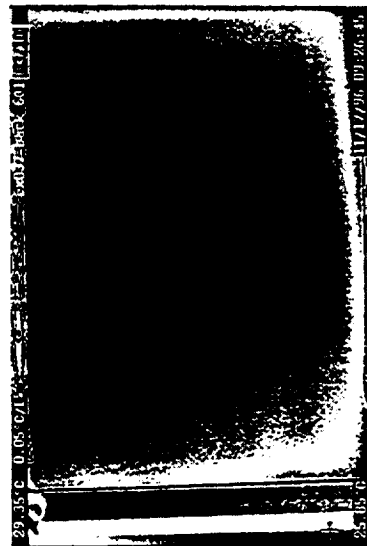
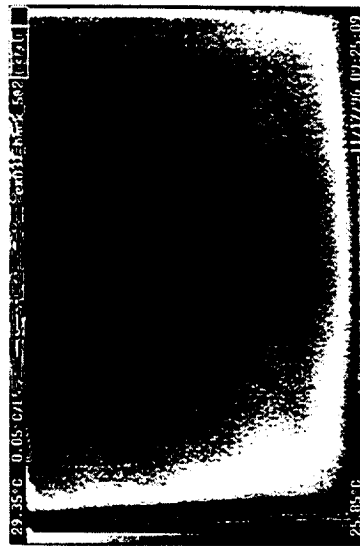
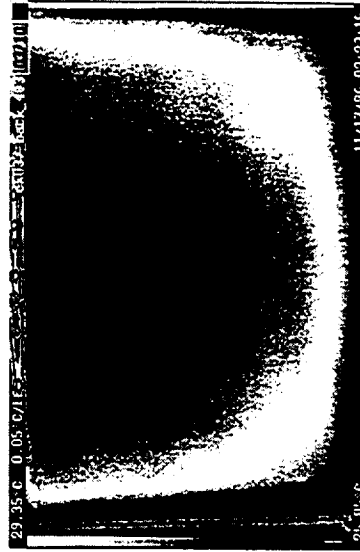
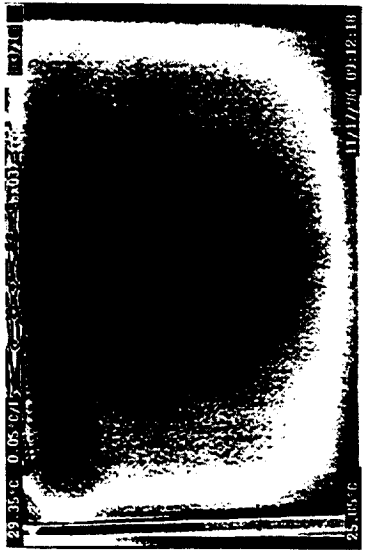
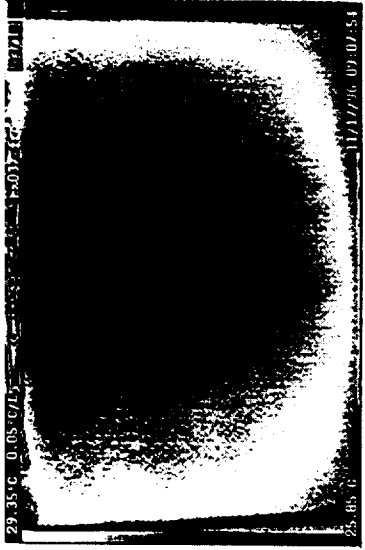
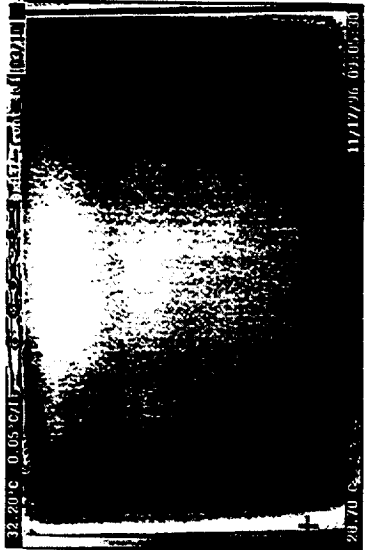
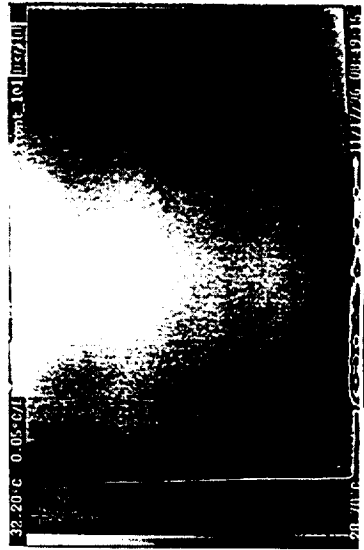
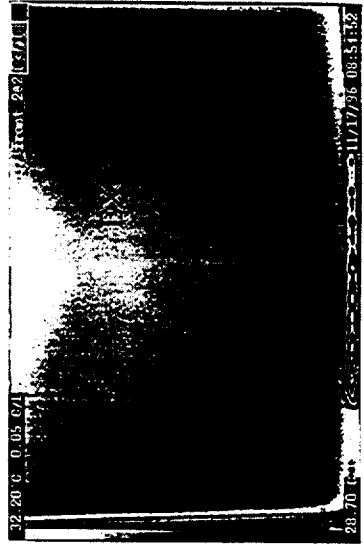
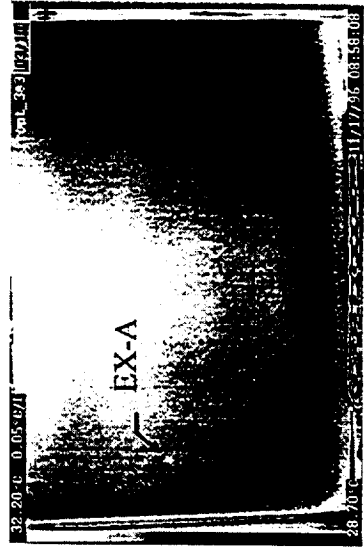
Panel EX037 Panel EX037 was constructed from 16 plies of gr/ep and measured 24"x 49". No scheduled defects were built into the panel. The panel was scanned in 6 segments per side using front side flash heating (1500v) and the Bales TIP. The frame delay was set to 20 msec.

The only defects found were a small abnormality located on the front side in quadrant 2 and 3.

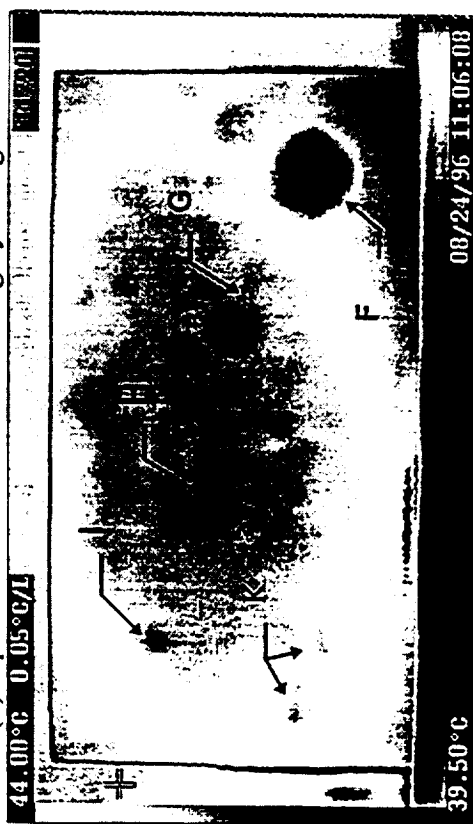
(3) Specimen C - Front side heating by heat gun

Specimen C is seen in images 3, 4 and 6. In images 3 and 4 a heat gun was used for the thermal excitation and the time delay set to 1 sec/frame. Image 6 was acquired with flash heating and time delay of 0.5 sec/frame. It is interesting to see that the flash imaged flaws are better defined than those obtained with manual heating, but not all flaws are found with flash heating.

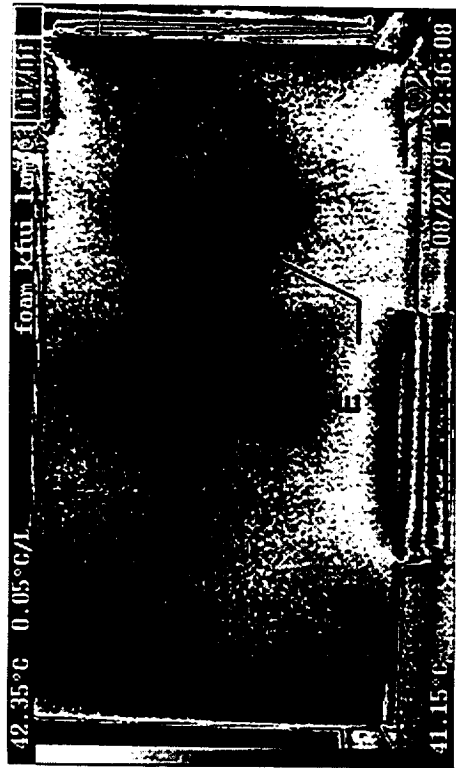
(2) Specimen B - Back side heating by 2-500 W lamps

Specimen B had inserts in the same position as specimen A. Image 2, produced by back side long duration heating by 2 - 500W heat lamps only showed the largest of these two defects, as one defect. No other heating method produced as good a results as the back side heating used for this image.

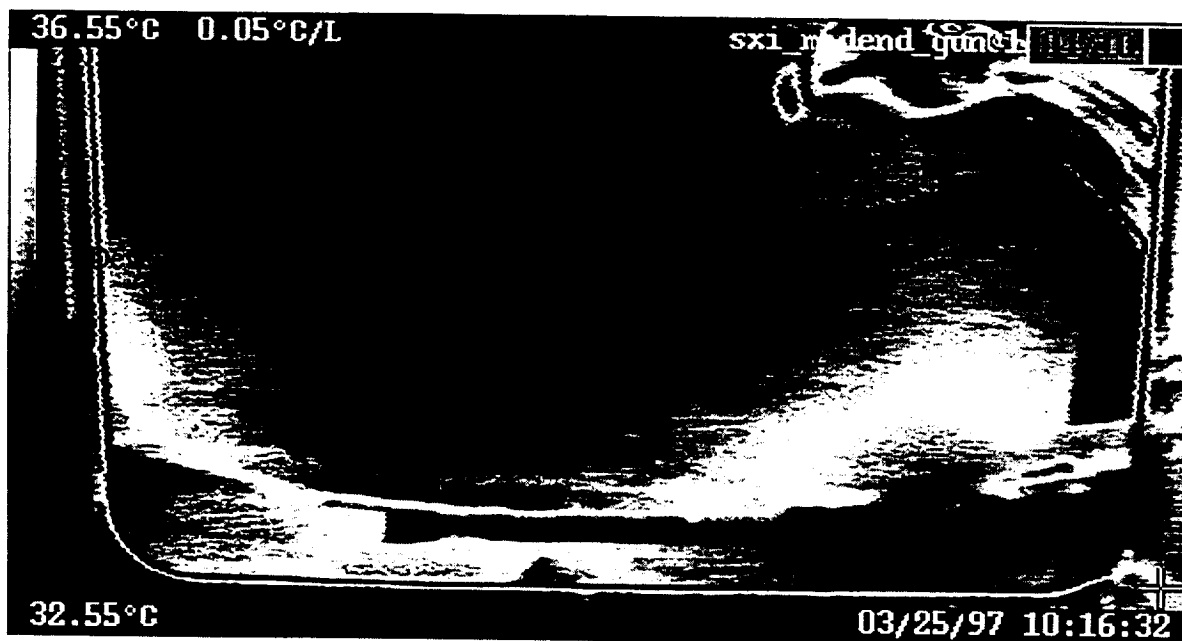
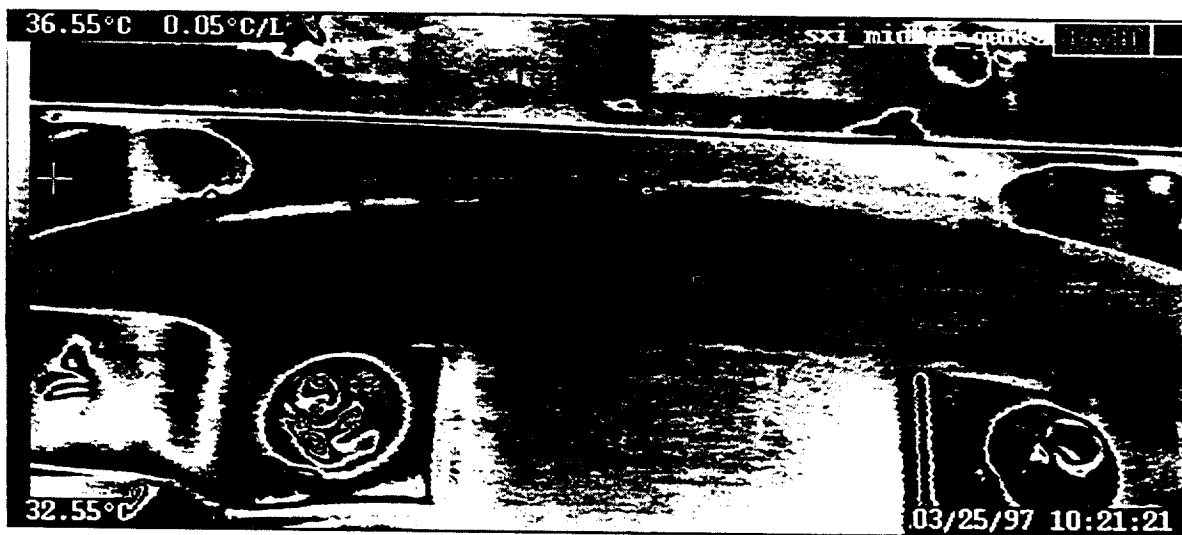
Mid-attach points (Heat gun)

The tube was inspected after failing a structural load test. In that test, the top attachment points tore loose. Of primary interest was the inspection of the mid-attach points where the mount had pivoted when the upper mount failed.

The images (both flash and manual heating) of where attachment pad 1 and 2 tore loose clearly show the regions where the tube delaminated upon failure. It was difficult to view the bondline during flash heating. During manual heating though, several discontinuities can clearly be seen. These discontinuities may be cracks "delaminations" formed due to the bending moment applied to the joint when the upper pads failed. The joint would need to be inspected with other NDE techniques such as ultrasonics or x-ray to verify these conclusions.

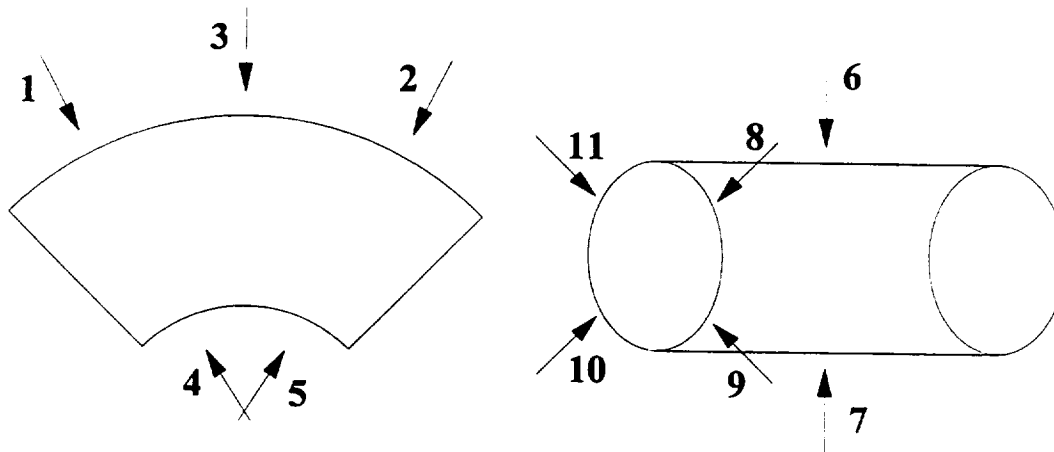
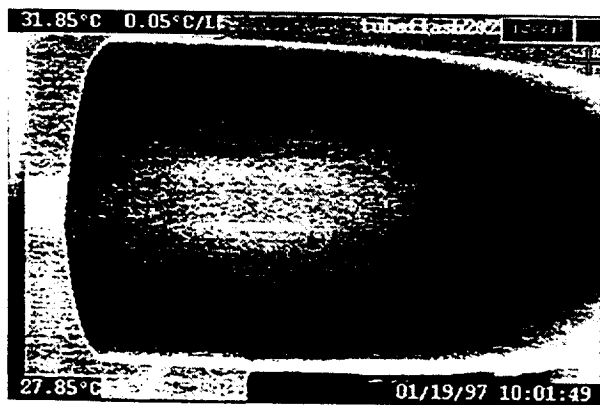
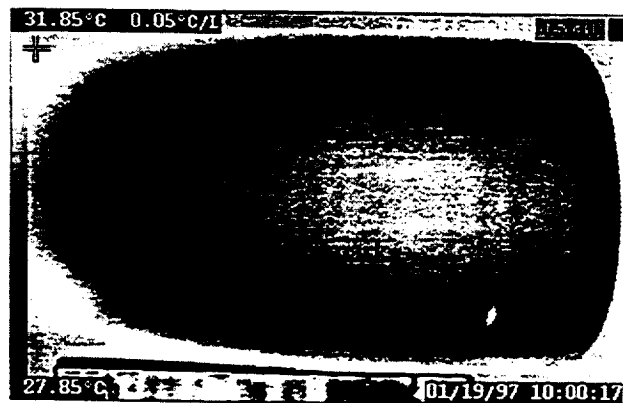
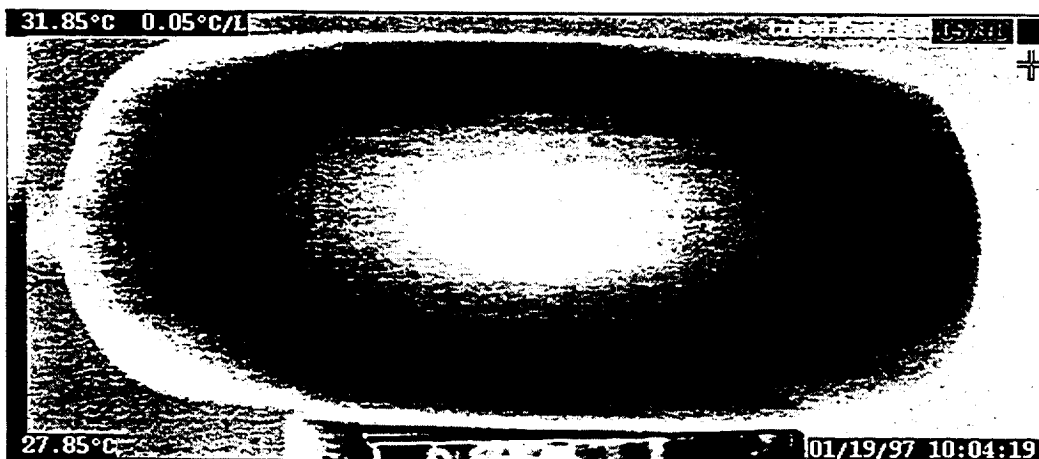
The only defects located or identified was a grinding mark, approximately 0.5 inch square, on the inside of the tube. The mark appears to be almost all the way through the tube, but is not visible from the outside. No scheduled defects were planned for this component.

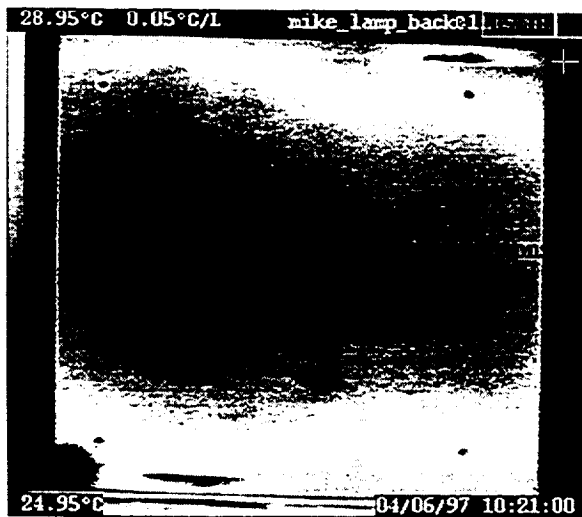
(5) Backside

Each bolt hole shows some degree of damage. The upper right hand bolt hole appears to be in the worst shape, with delaminations running approximately 1/4 inch up and down the panel.

There also appears to be some form of subsurface feature below the visible surface wrinkle on the top of the panel. Without a reference standard it is difficult to tell if the thermal inspection is reaching the core/faceplate interface.

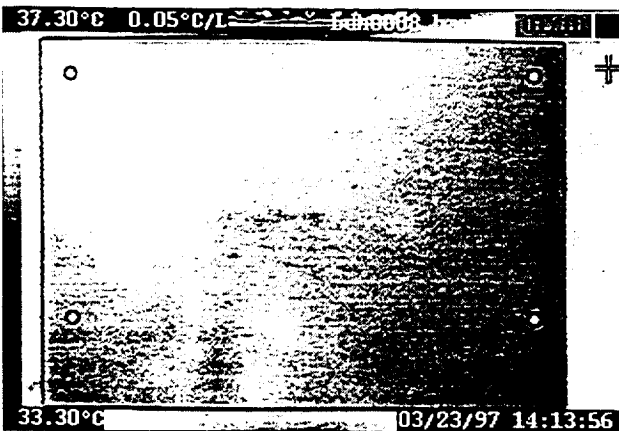
BDH0008 - Tool side

This program, part of the Shuttle Upgrade 2030 Project, has continued after a hiatus of a year. A concern when the program ended last year was the cause of certain delaminations and blisters that occurred just below the surface of these full-size layups during thermal dynamic testing. This condition was not prevalent on the flat panel specimen testing. A suggestion was made to find the reason for this. Was it volatile gases escaping from the edges? It was decided to tape the edges of the side of the panels with different compounds to see if this would cause similar conditions as that found on a full-size component where edge effects are not prevalent. One panel was sealed with a red silicon adhesive, while the other panel had a dark Havaflex Ceramic compound sealant. The objective was to perform hot gas testing on these panels and then measure the  $\Delta P$  vapor pressure on the part and correlating that with other tests. It was expected that 80% of the volatiles consists solely of methanol.

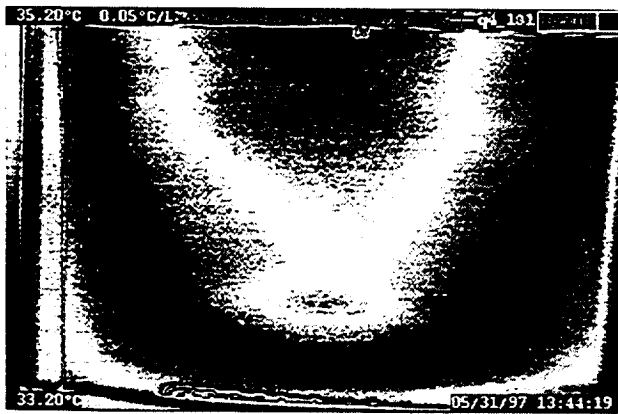
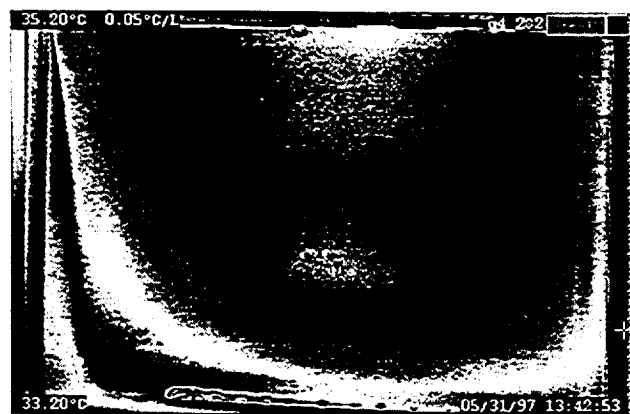
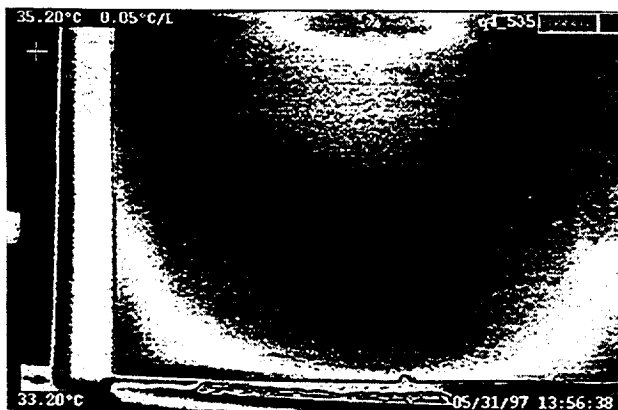
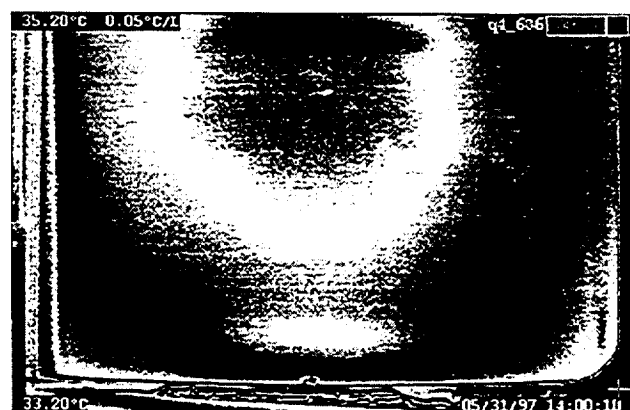
#### 5.14 Thermography Of Space Station Rack Rear Access Panel (Q4)

- Good correlation with porosity region detected by UT.
- Porosity not detectable from front surface scan of rack.

Close-up of porosity
